New Jersey library

**Reading, 'rithmetic,
redesign pay off**

LIBRARY'S FRAMING IS AN OPEN LOOK

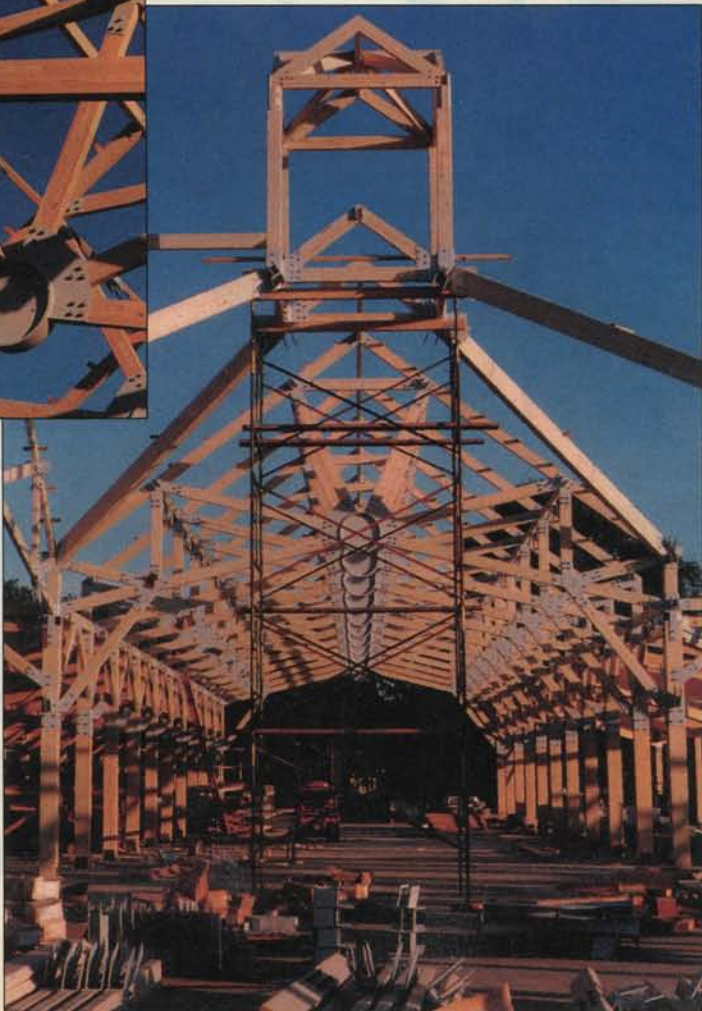
Timber on high: Laminated timber trusses were fine-tuned after initial design was completed based on the architect reading reports that lumber prices were about to skyrocket. The redesign cut weight and quantity, saving \$100,000 on the \$700,000 timber contract. Falsework was required before lifting the last piece of the atrium-area puzzle—the cupola (right).

In general, and especially under the cupola, "the architect was looking for consistency in member sizes," he adds. It was not simple to have a stable cupola with standard members, but "the roof diaphragm action helped." To simplify erection, workers built the cupola on the ground and lifted it.

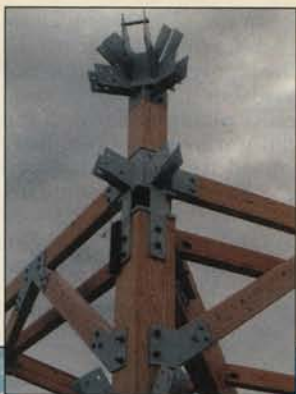
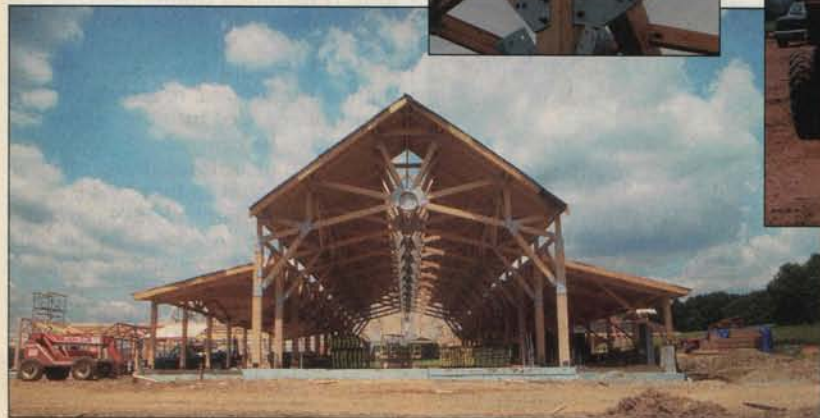
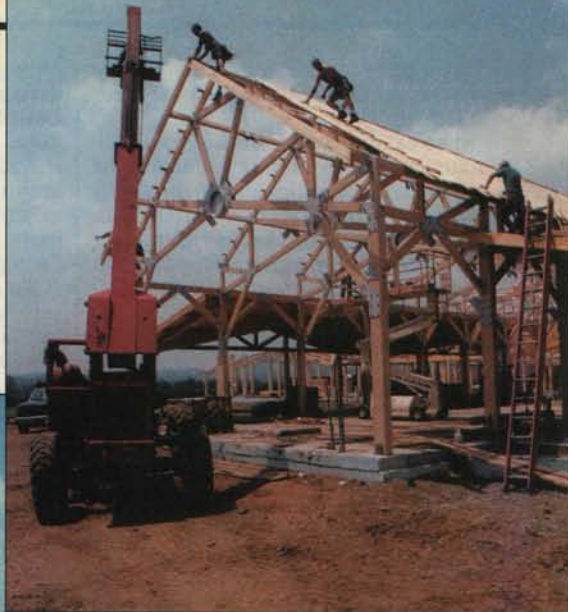
Fine dimensioning of all members, fabricated with bolted steel connectors (right), combined with tight tolerances, made erection of the exposed-on-the-inside framing that much more demanding. Scissor-like trusses in a row form peaked roofline with continuous skylight (below). Like ants, workers climb over the roof to install decking, which provides diaphragm action.

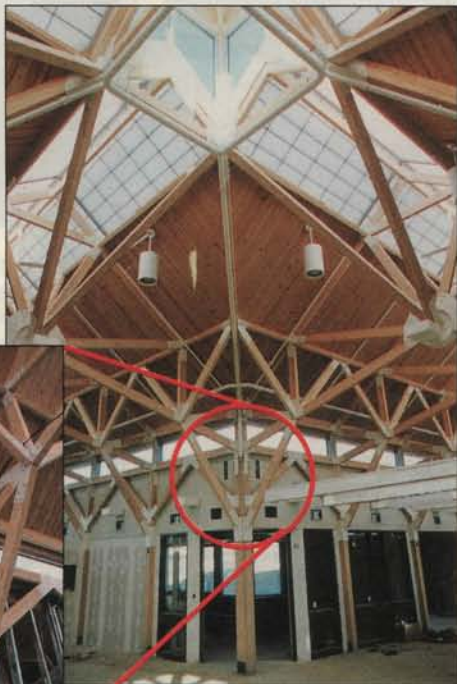
Angles, elevations complicated the exposed sprinkler piping. To cope, the sprinkler subcontractor had put the piping layout on a CAD file. Still, the job, with almost no standard fittings, was even more labor intensive than anticipated. Piping comes through column, runs along angled member.

piping jobs but not with varying elevations and 16 different and odd angles," caused by the piping following the roof slope. "It was labor-intensive," he says.

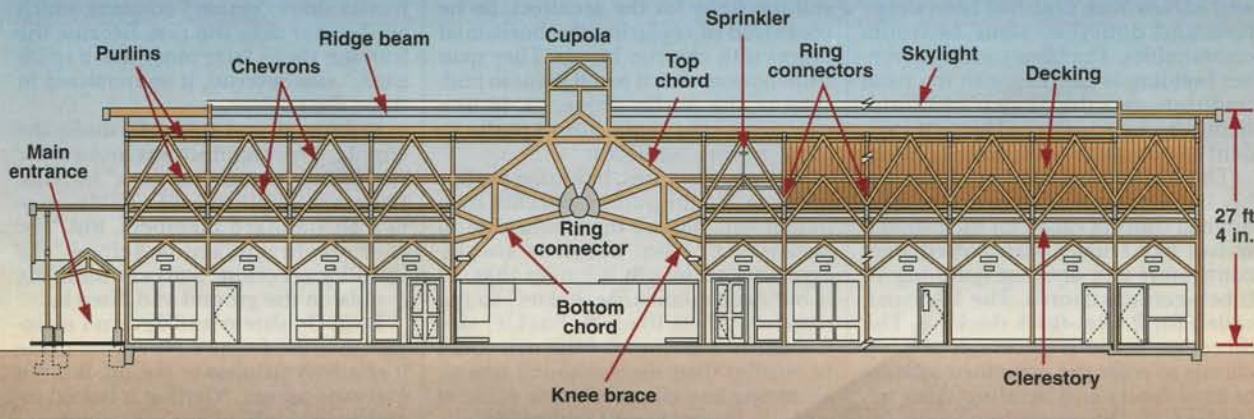
Redesign added purlins, chevrons and switched decking direction but maintained initial concept, shown in model of original cupola area (top).

In the initial redesign, Goldstein added a row of Glu-lam 3x9 purlins at each panel point of the trusses, which allowed him to change the direction of the decking from longitudinal—truss to truss—to transverse—purlin to purlin. That reduced the decking span from 10 ft to an average 5 ft. The shorter span allowed the sawn-lumber decking to be 1.5 in. thick, which costs less per running foot than 2.5 in. And as combined loading was no longer needed, the top chord went from a GL3x12 to a GL3x7, says Goldstein.

There's more. The GL3x9 purlin was still too hefty for the architect. So he conceived of replacing the horizontal braces with chevron braces. They span from bottom chord panel point to midspan of the purlin above, or, in one case, from ring connector to purlin to adjacent ring connector.
